7. BUILDINGS + INFRASTRUCTURE

This section discusses regional and local transportation infrastructure that provides access to the SDC site as well as access within the site for automobiles, bikes and pedestrian movement, including condition of roads and sidewalks. It also summarizes the condition of site-wide infrastructure such as water distribution systems, storm-water drainage, sanitary and sewer systems, utility network, and condition of existing buildings. General estimated costs of rehabilitating infrastructure and buildings are reported.

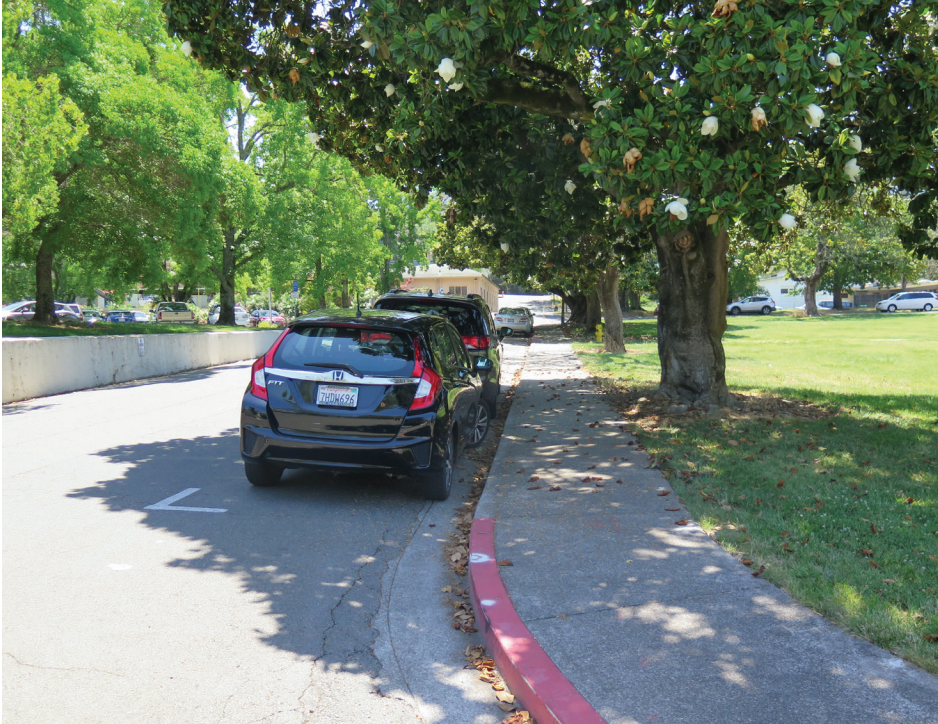
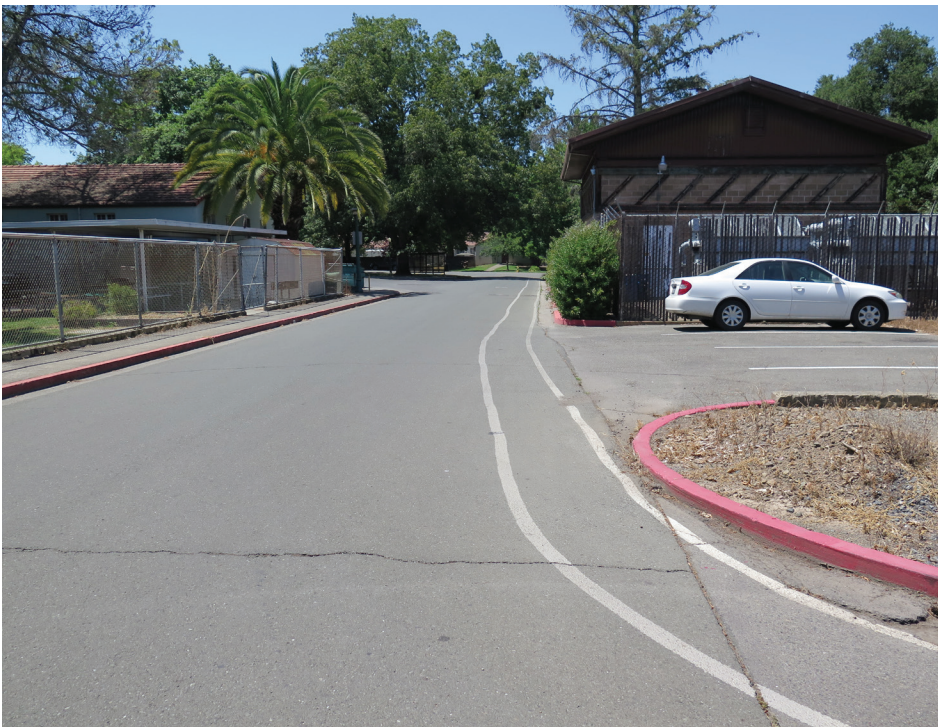
On-street parking along internal streets on the SDC site (top). Painted sidewalk (bottom).

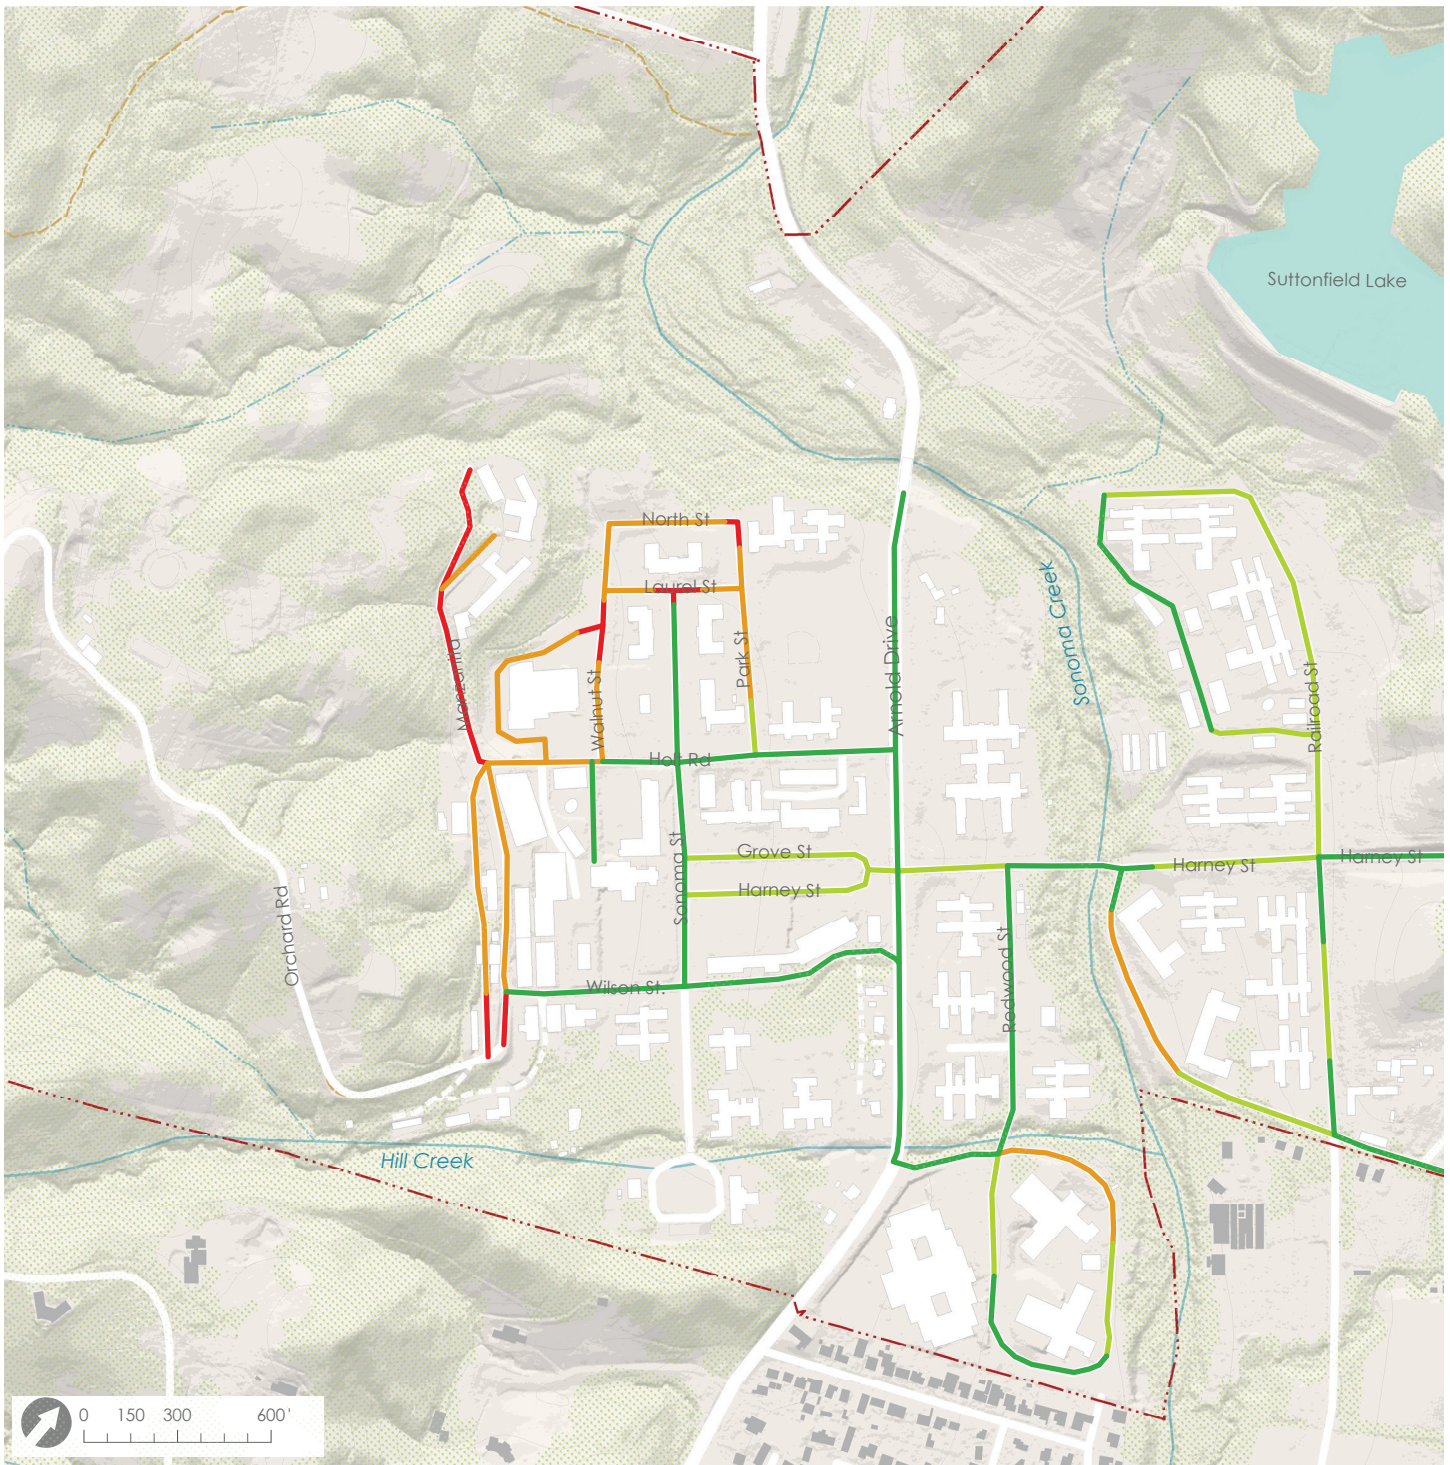
Figure 7-6

Most of the main campus is laid out with concrete curb, gutter and sidewalks. Most buildings have a significant amount of parking and paved service area around them. Most of the sidewalks have modest to severe issues from minor cracks

to broken and uneven pavement. In several locations, sidewalks have cracked at the control joints, and adjacent slabs are significantly out of alignment posing extreme tripping hazards. Roadways are paved with asphalt and the condition of these roads varies from excellent to very poor. Pavement conditions are shown on Figure 7-6. Refer to the full Sherwood Design Engineers report included as Appendix B for additional analysis.

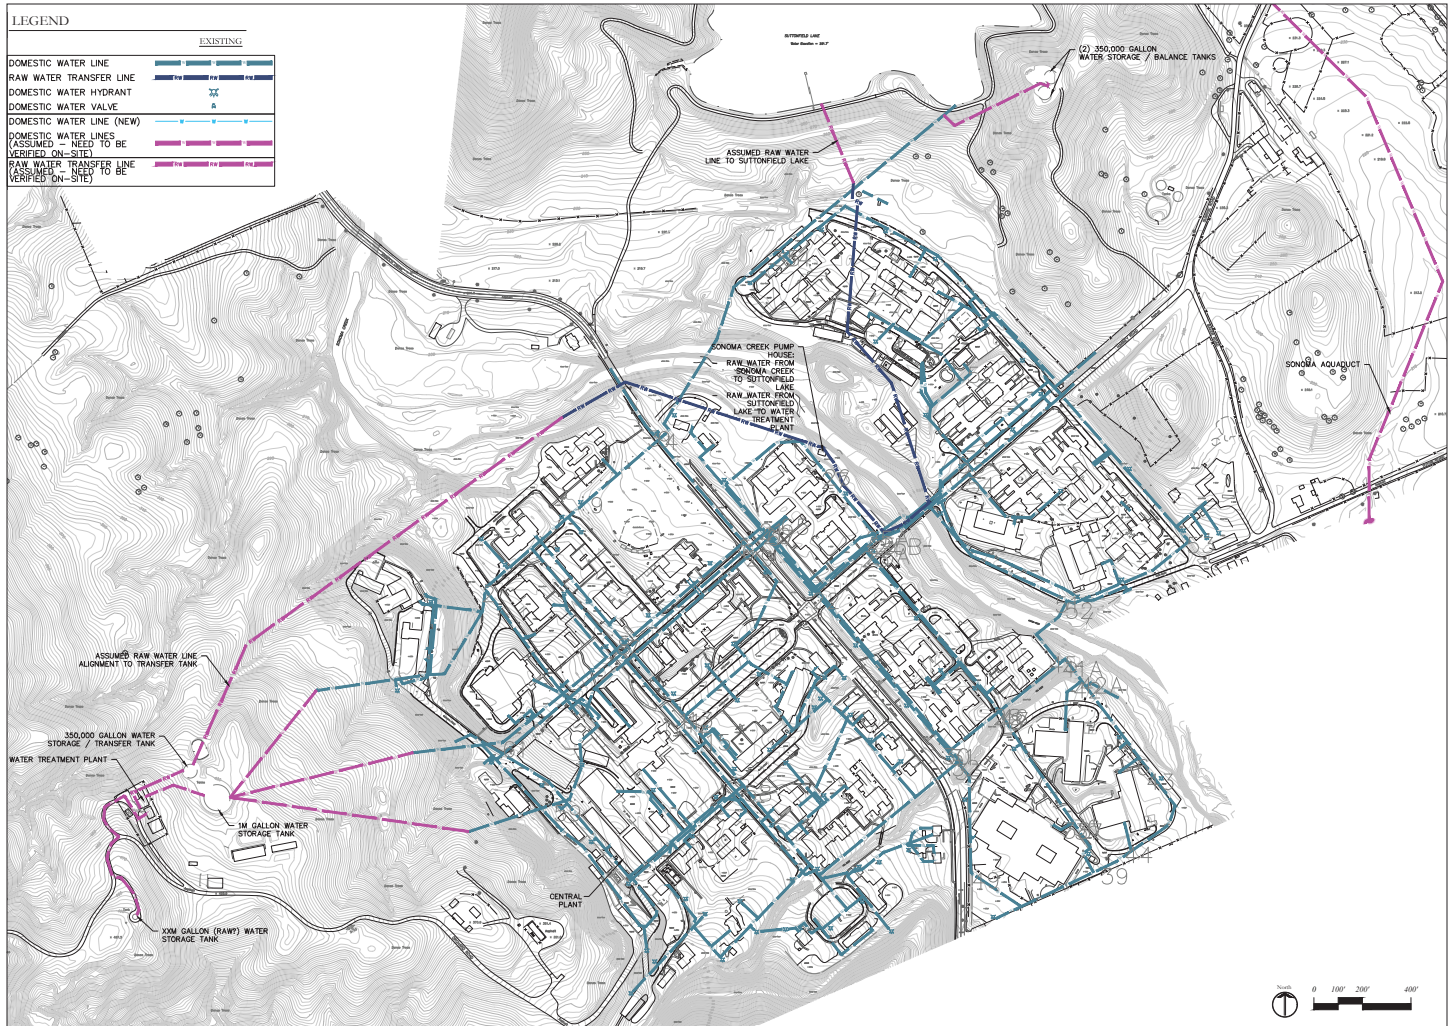
Figure 7-8
WATER SYSTEM

Figure 7-8 illustrates that there are two or more parallel water lines that appear to all be serving the same purpose: increasing flow to buildings without having to install a larger pipe. While with the double pipe system it is easy to make repairs without inconveniencing users because of all the valves and double piping, it also poses different maintenance challenges in that there are a lot more joints, valves, and fittings that could break or leak.

Originally constructed 60 to 100 years ago, the water distribution system has experienced numerous repairs and is now a patchwork of pipe materials. Most of the water mains were built with asbestos-cement (A/C, also called Transite) pipe and laterals with galvanized pipe. Additionally, welded-steel or ductile iron pipe has been used as a material of choice for transmission lines and in some areas, cast-iron pipe has been used for water supply. While A/C pipe is quite durable if undisturbed, it is brittle. In soft or unstable soils or near mature trees, breaks will occur. Galvanized and cast-iron pipe will rust over time. These older pipes are very much at the end of their useful life. Over the years, many repairs have been made, usually using PVC pipe to repair the damaged section of pipe. In 1995, a new water main was installed in the main campus with C-900 pipe (PVC pressure pipe). This relatively new water main is 22 years old and should have at least another 50 years of life left in it. Everything else is considered obsolete.

Modeling the water distribution system would give us an understanding of its capacity for future development. However, the system's complexity, age and condition present substantial challenges. Because the system is in such deteriorated condition, and replacement is recommended, there is little value to be derived from modeling.

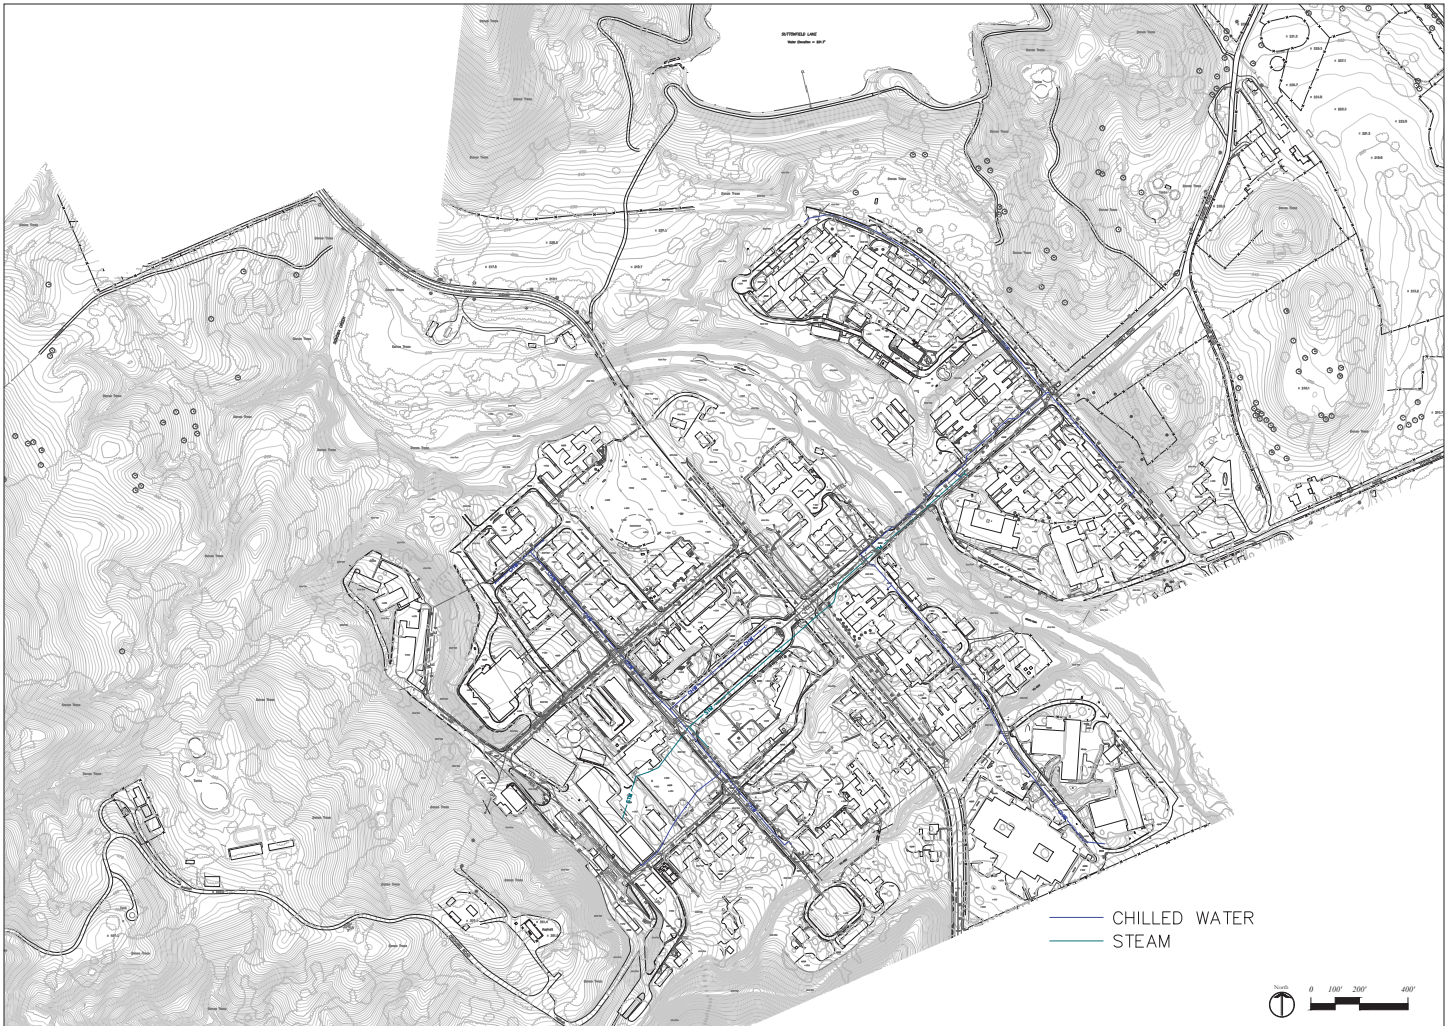
Figure 7-12

- The plant cooling system consists of two chillers in good condition.
- The plant heating system consists of three boilers (installed between 1950 and 1970) which are in fair but aged condition and would need replacement for continued use.
- The plant cooling towers are in fair condition.

- The Site Emergency Generators consist of three units in good condition.
- The Building Management System (BMS) is tied to (16) buildings throughout the campus.
- Site distribution: Underground steam and condensate pipes are in poor condition in the north-west part of the campus where condensate is not being returned to the plant and will require extensive repair for future use, therefore the system is considered obsolete. Chilled water system is in better condition, but would require extensive investigation for future use.

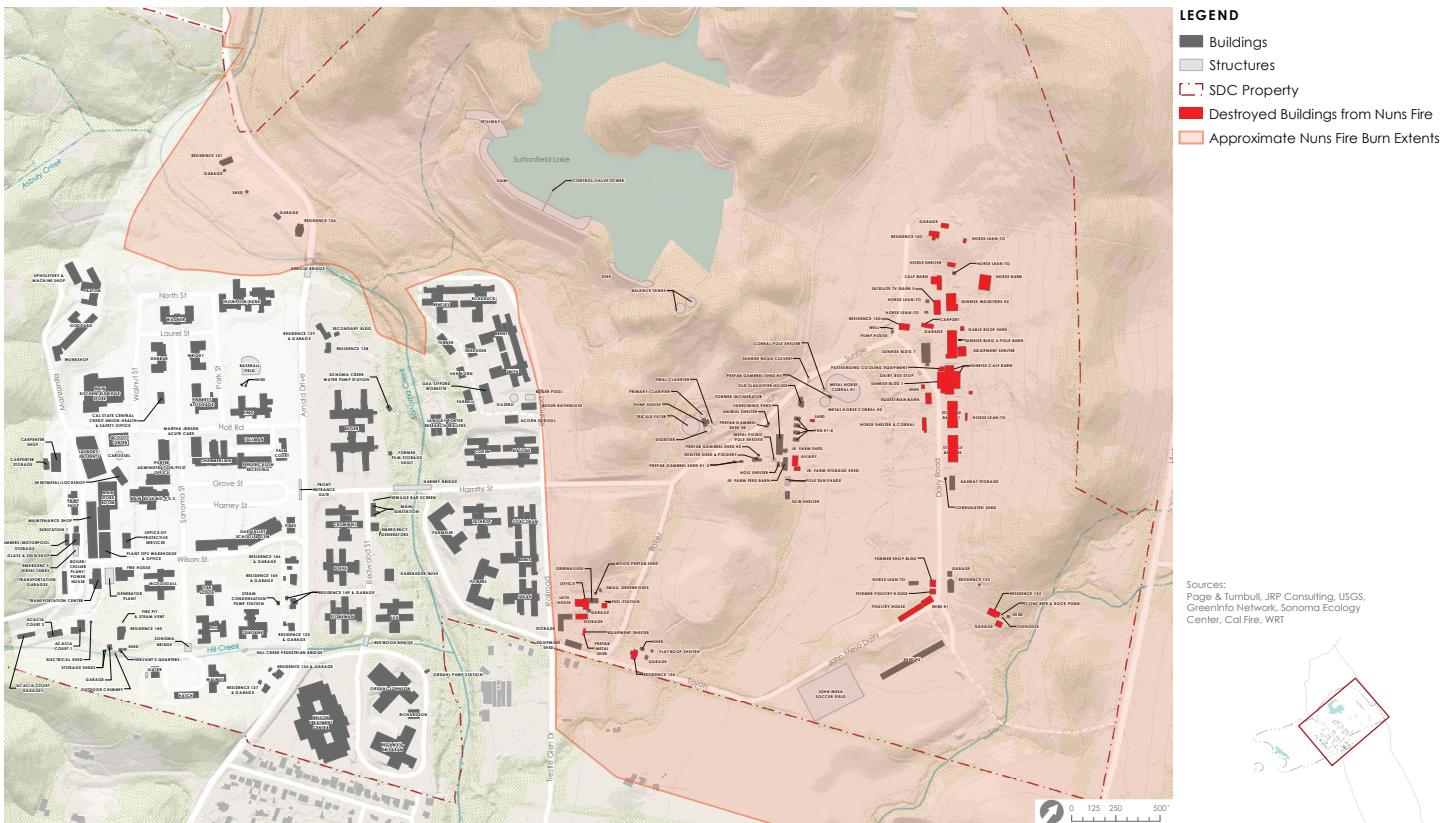
Figure 7-16

EXTENT OF THE NUNS FIRE AND FIRE-DAMAGED BUILDINGS AT THE SDC SITE

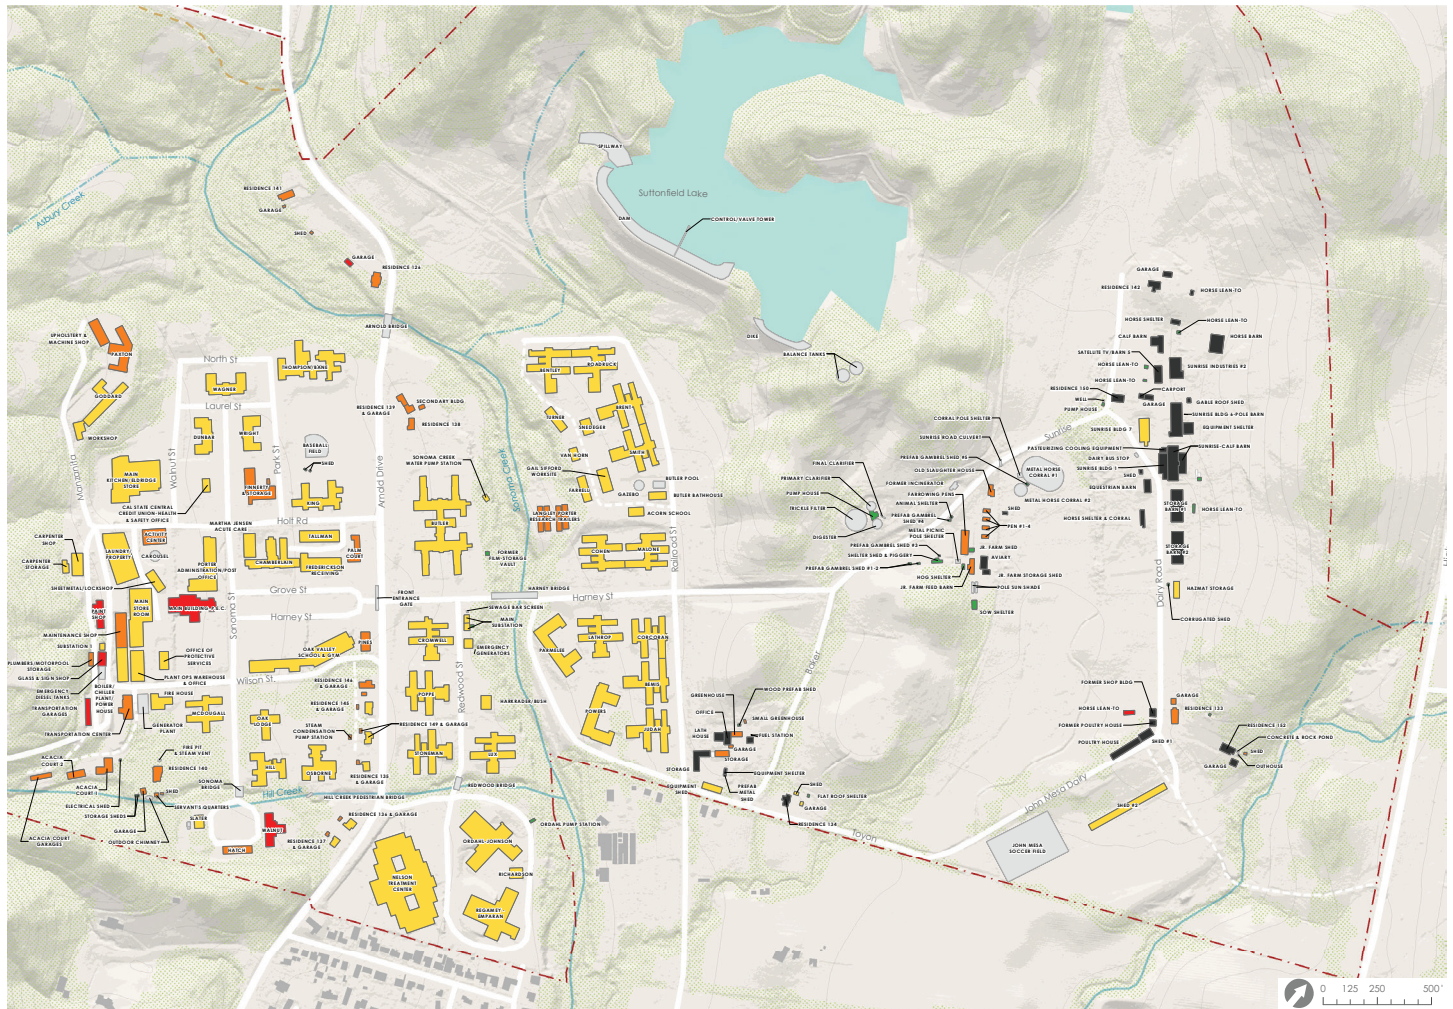
Figure 7-18

The building architectural evaluation (Figure 7-18) reviews the material construction and deterioration of the buildings. The evaluation provides an overall summary that considers foundations, exterior and interior walls, roof, windows, and doors.

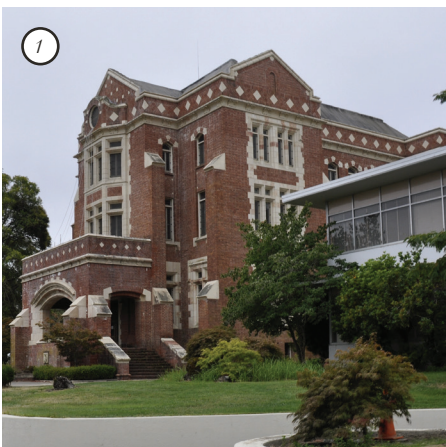
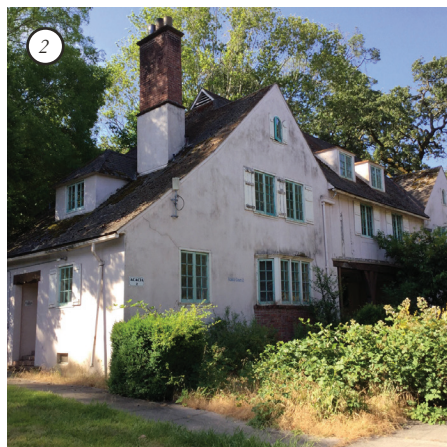
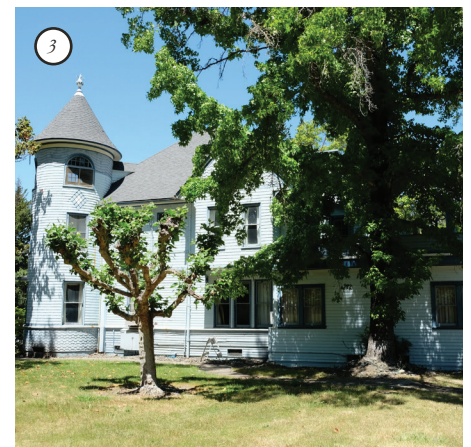
C2 – CONCRETE SHEAR WALL WITH STIFF DIAPHRAGMS

Construction Description – All structures of this type were observed during the Level 1 Rapid Assessment, which was limited to cursory visual observation of the interior and exterior of the building, and most were included in the Level 2 Detailed Assessments. All of these structures have full or partial original construction documents.

Recommended Strengthening – For lower performing structures a more detailed investigation and material testing program needs to be implemented to allow for a complete structural building analysis model to be developed. The findings of the structural model analysis may mitigate some of the identified deficiencies and will provide sufficient information to develop structural strengthening recommendations. Additional reinforced concrete shear walls, boundary elements, and reinforcement at openings and coupling beams should be anticipated to resolve known deficiencies.

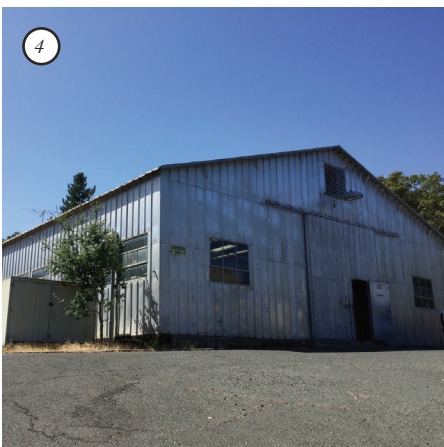
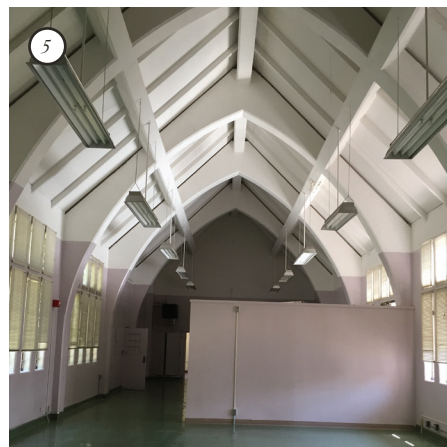
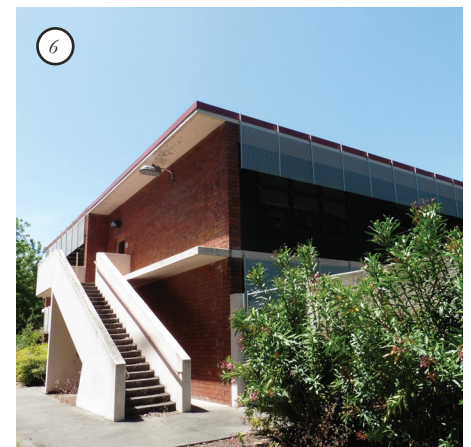
C2A – CONCRETE SHEAR WALL WITH FLEXIBLE DIAPHRAGMS

Construction Description – All structures of this type were observed during the Level 1 Rapid Assessment, which was limited to cursory visual observation of the interior and exterior of the building, and most were included in the Level 2 Detailed Assessments. Access to attic and crawl spaces were not available to the observation team at that time. However, all of these structures have full or partial original construction documents, with the exception of Hatch.
