PRELIMINARY GEOLOGIC HAZARD REPORT
SONOMA DEVELOPMENTAL CENTER
15000 ARNOLD DRIVE
ELDRIDGE, CALIFORNIA

JOB NO. 7692.01

Subject: Preliminary Geologic Hazard Report
Sonoma Developmental Center
15000 Arnold Drive
Eldridge, California

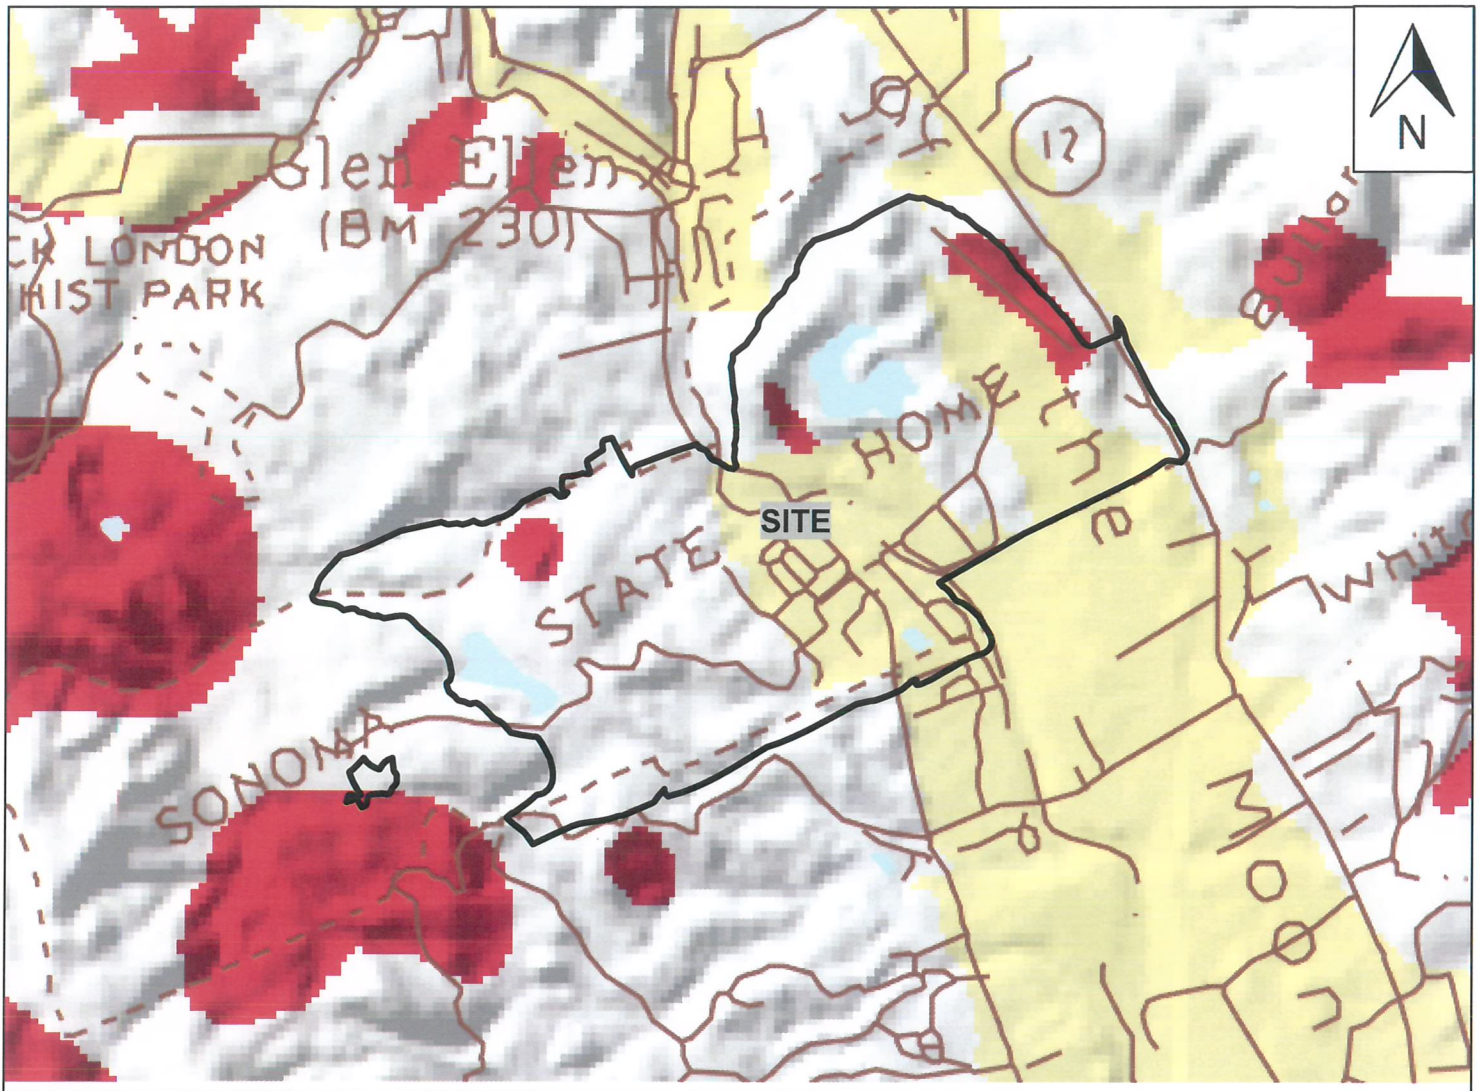
**PLATE
 10**

The CGS geologic map indicates a total of six landslides partially or entirely within the boundaries of the project site. Furthermore, we observed several landslides at the project site which are not indicated on the CGS regional geologic map, including a landslide along Orchard Road, and a 2001 bank failure along the Sonoma Creek. Furthermore, it is our understanding a landslide in 2001 damaged a water supply line from the spring at the upper western margin of the project site. We also observed a small landslide above the concrete spillway at Lake Suttonfield. We observed hummocky terrain features in the sloping grasslands below Fern Lake. The hummocky terrain is indicative of global landsliding. We recommend the existing landslides and unstable slopes should be mapped in detail. Following mapping, the landslides should be evaluated by a subsurface exploration, laboratory testing, and analysis.

A notable mapped landslide is a massive complex west and above

Fern Lake. The majority of the massive landslide complex is within Jack London State Park, although the toe of the landslide extends down to the western shoreline of Fern Lake. Furthermore, another massive older landslide complex has been mapped beyond the northern border of the project site. The mapped large-scale landslide within the project site boundaries appears to be a relatively old feature which was likely triggered during a climatic wet period of the Pleistocene epoch which coincided with a significant seismic event. Based on our site reconnaissance there are no obvious indications that the global mapped landslide is actively moving. However, a detailed study of the mapped global massive landslide complex is beyond the scope of this project. Large-scale global landslides can be triggered during severe seismic events which coincide with extreme wet periods. Based on the results of our investigation, we judge that the project site is located in an area which is considered to have a higher than normal risk for displacement and deformation resulting from earthquake-induced landsliding. We recommend a more in-depth subsurface exploration, laboratory testing, and analysis. Detailed geologic mapping and geotechnical evaluations should be performed to determine the locations and activity of landslides at the project site.
