7. BUILDINGS + INFRASTRUCTURE

This section discusses regional and local transportation infrastructure that provides access to the SDC site as well as access within the site for automobiles, bikes and pedestrian movement, including condition of roads and sidewalks. It also summarizes the condition of site-wide infrastructure such as water distribution systems, storm-water drainage, sanitary and sewer systems, utility network, and condition of existing buildings. General estimated costs of rehabilitating infrastructure and buildings are reported.

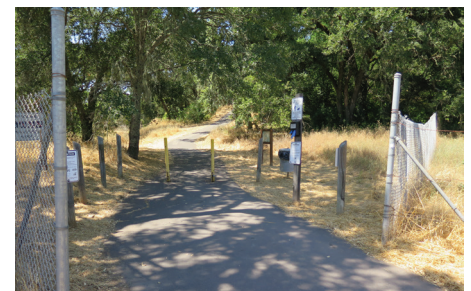
Entrance to Sonoma Valley Regional Park

A trailhead and entrance to the Class I multi-use path in Sonoma Valley Regional Park is located on the east side of Arnold Drive north of the Sonoma Creek Bridge. People walking and riding bikes southbound along Arnold Drive must yield to oncoming auto traffic to cross the street and access the multi-use path, creating a hazardous situation.

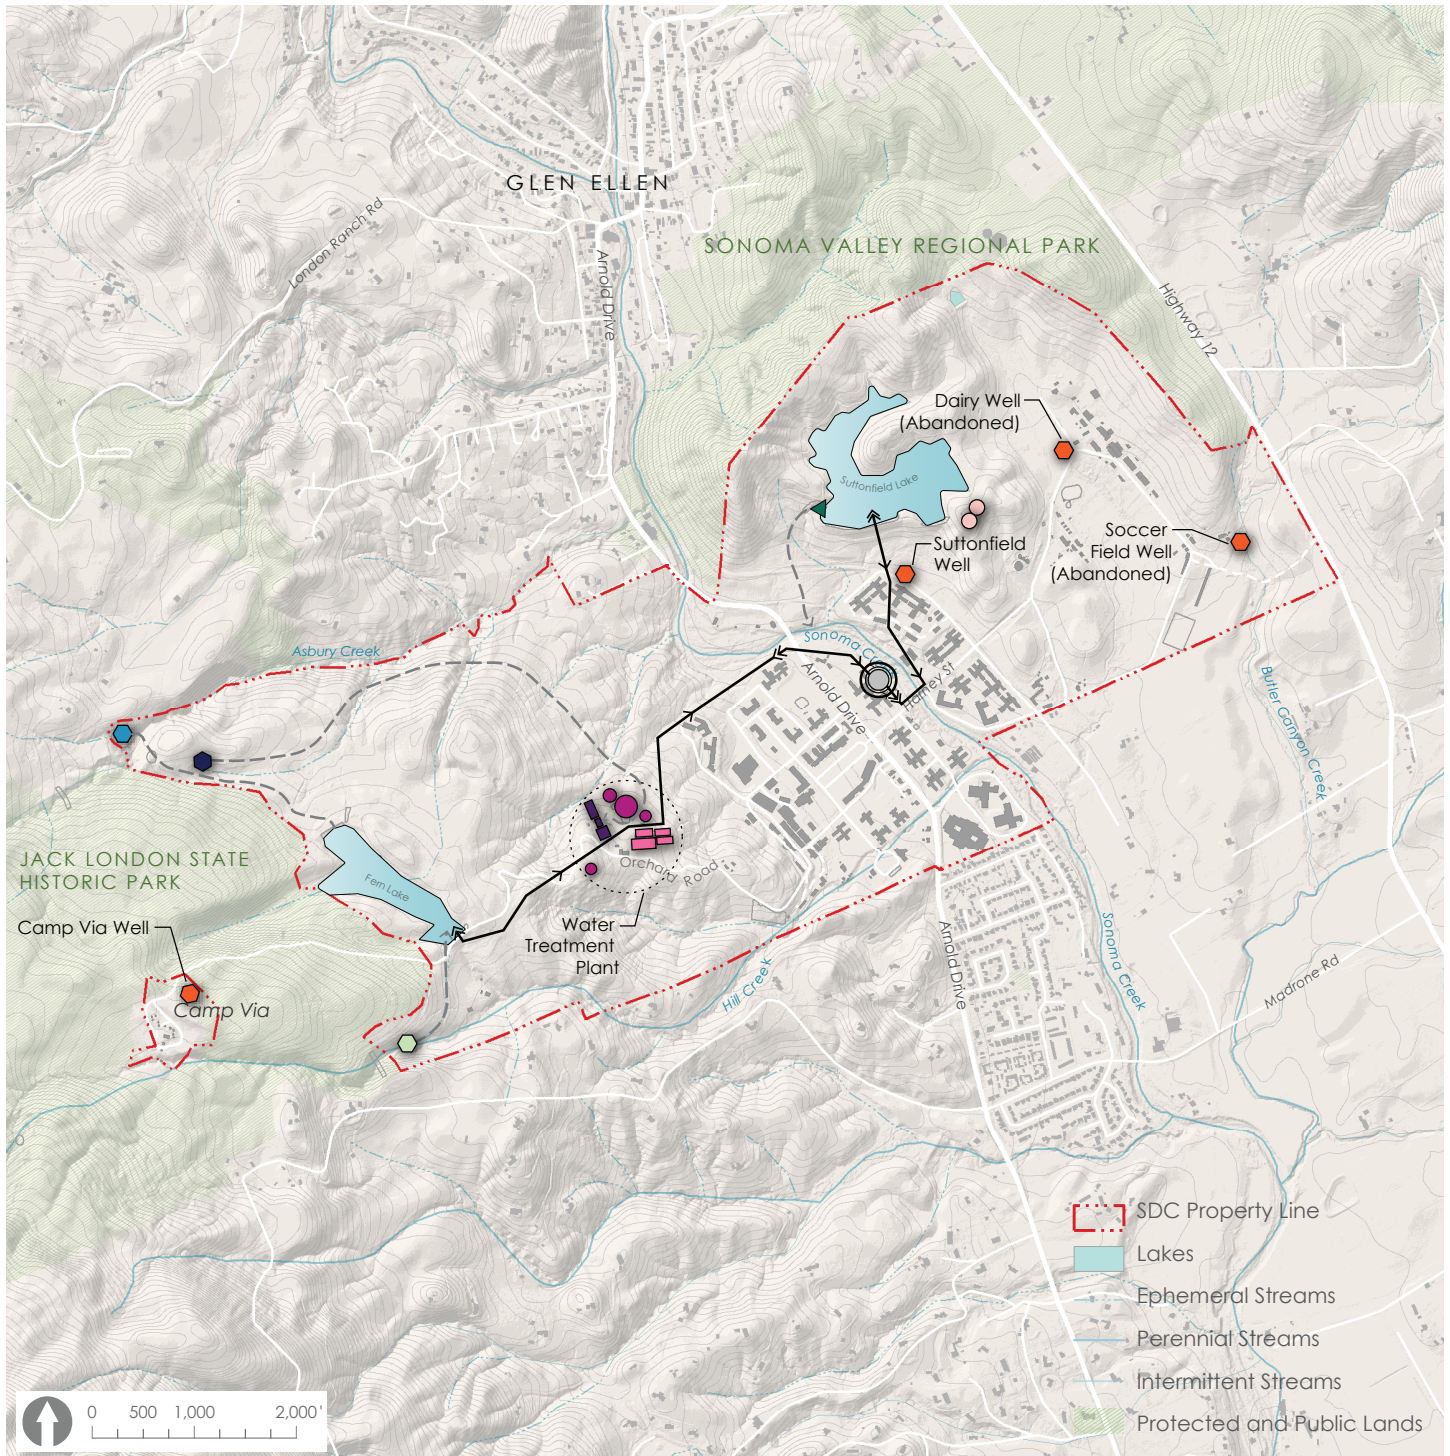
Figure 7-7
WATER SUPPLY SYSTEM

The raw water transmission line is a single 10-inch ductile iron (DI) pipeline. Joints in the original pipeline were packed with lead and oakum. Over the years, some sections of the pipe have been repaired and replaced with PVC. The pipeline is designed to flow in either direction by manually opening and closing several valves and pumping in the reverse (uphill) direction.

The approximate routing of the raw water transmission line is shown on Figure 7-7 and conveys water by gravity from Fern Lake to the Pressure Break Tank adjacent to the WTP. The break tank is a partially buried 25,000-gallon covered concrete tank under the trees near the recirculation water storage. This tank is necessary to relieve the pressure in the system before transmission to the lower part of the property.

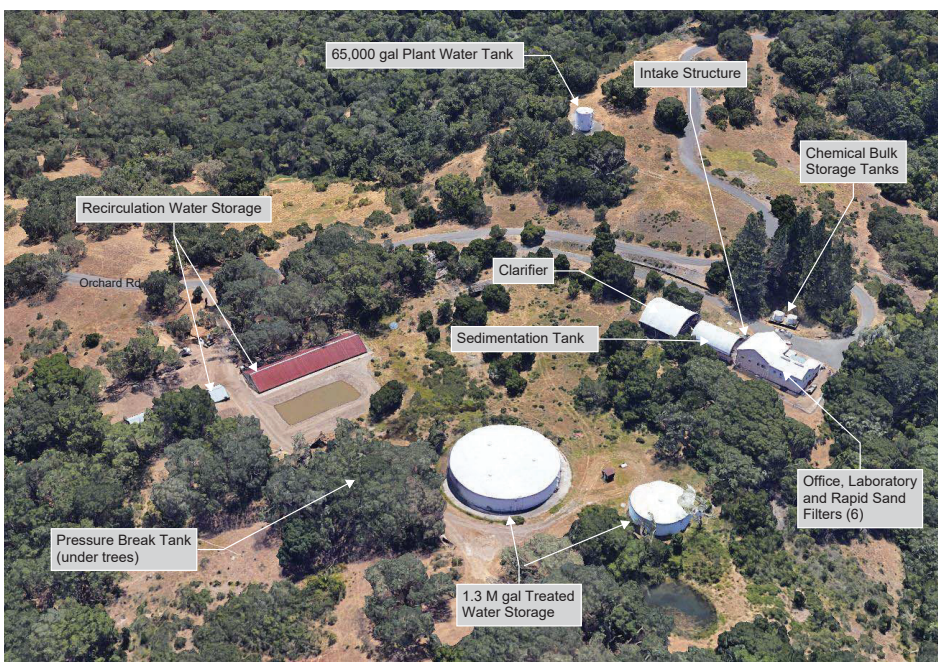
A bird's-eye view of the water treatment plant at SDC.

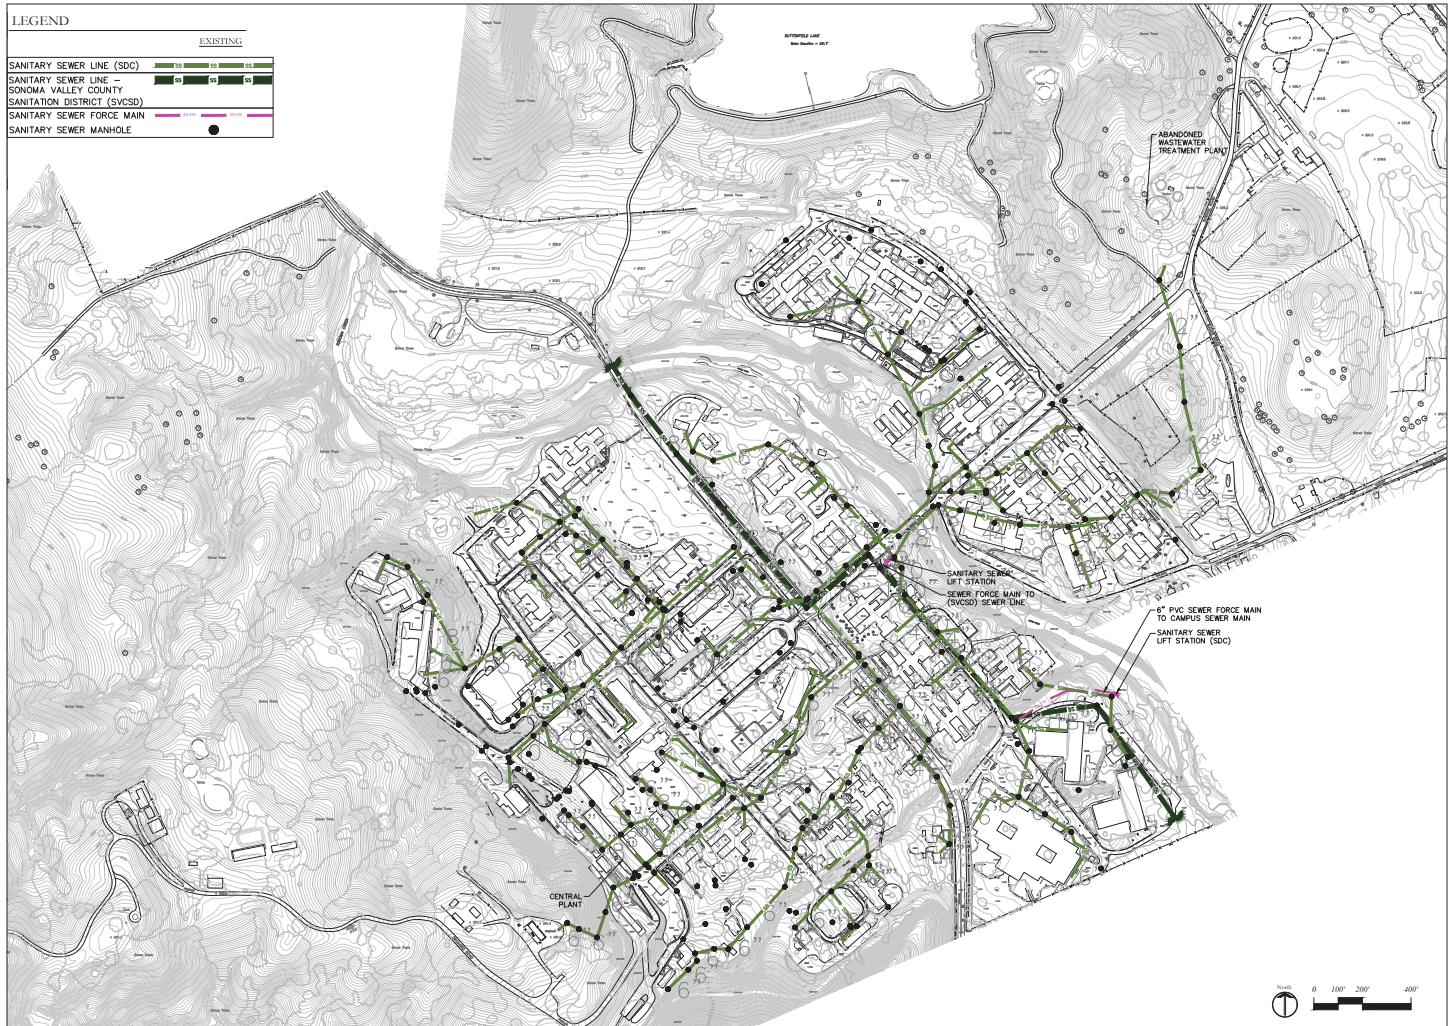
Figure 7-9
SANITARY SEWER SYSTEM

The sanitary sewer collection system is reported by SDC facilities staff to consist of primarily vitrified clay pipe for the sewer mains and cast iron for the laterals. However, much of the system was built in the 1920s and '30s and there have been numerous failures and blockages over the years. Staff have attributed the blockages to be caused primarily by root intrusion. Much of the cast-iron pipe has rusted through. Repairs on the system have been made as required, normally with PVC replacing damaged pipe sections. The system should be cleaned and inspected regularly, but the SDC has not had sufficient staff to do so as a part of the regular maintenance schedule. Although most of the PVC sections are probably in fairly good condition, because of the patchwork nature of the system, the entire system is considered to be obsolete and in need of replacement. Refer to Figure 7-9 for a map of the sewer system. The extent of the system to be replaced will depend upon the extent of future development. If the property is developed in a manner

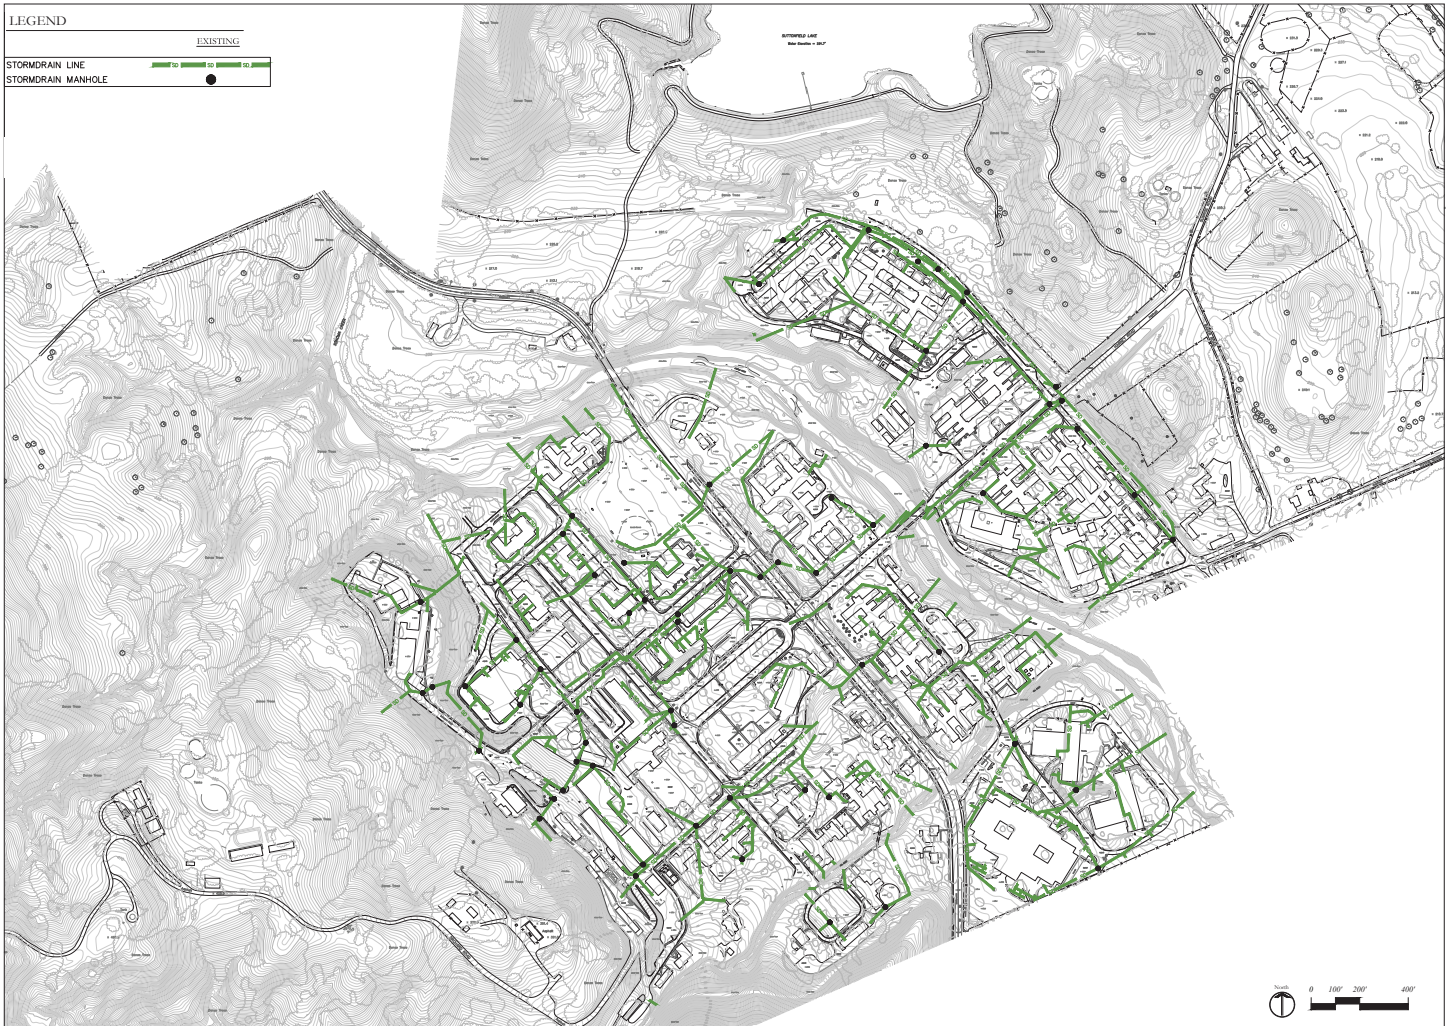
Figure 7-10
STORM DRAIN SYSTEM

- Most buildings have roof gutters and downspouts hard piped to a private, campus-owned below grade storm drainage system that discharges to the municipal storm ditch.
- Larger buildings, like the Nelson Treatment Center and Frederickson Receiving building, have roof drain systems with cast iron roof drain leaders inside the building.
- Minor maintenance types of drainage problems were observed, but the drainage system appears to be functional in general.
- Record drawings of the existing systems for verification of pipe sizes and routing were not available.

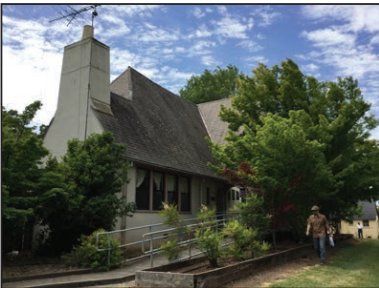
RESIDENCE 141 (1897)
DGS#11053

The various single-family residences, for the most part have maintained occupancy, and thus are in relatively good repair. Exceptions include one multi-unit building (Pines), Residence 146 Yellow House, and Residence 152, which all have interior mold issues, and Residence 141 where a small fire in 2016 has precluded continued use.

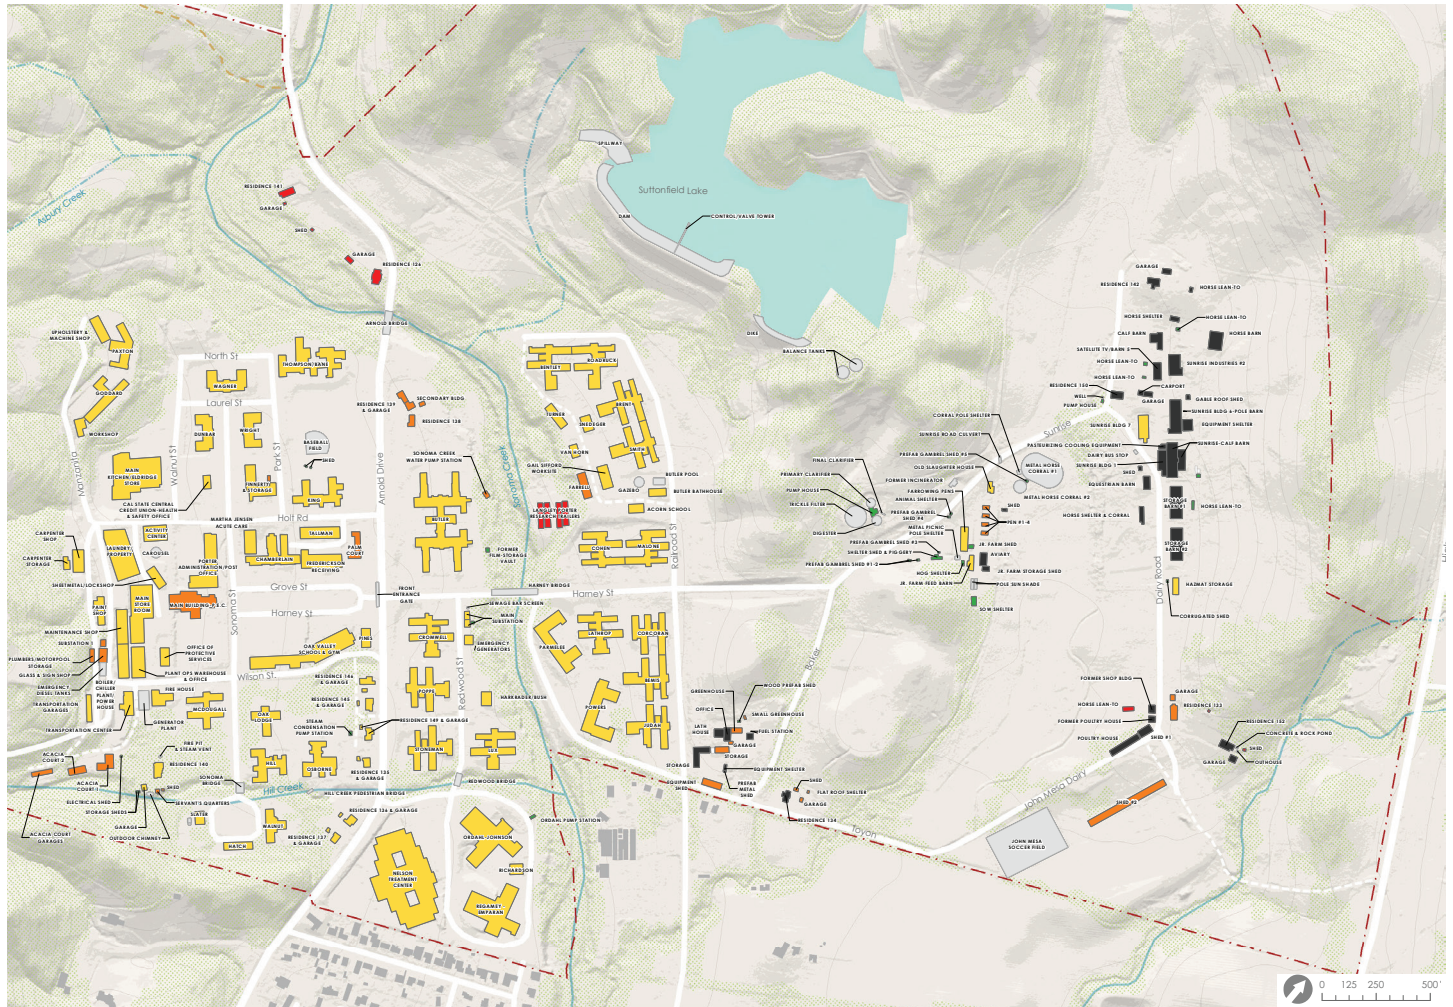
Exterior Building Accessibility Figure 7-17: this map summarizes exterior accessibility and feature conditions of the immediate site surrounding each building. The evaluation considers nearby parking, ramp access, and site features such as paths, walkways, stairs, entryways and building orientation. Updates required are qualified as minimal, moderate, or significant based on the relative site conditions:

The building site evaluation shown on Figure 7-17 summarizes exterior accessibility and feature conditions of the immediate site surrounding each building. The evaluation considers nearby parking, ramp access, and site features such as paths, walkways, stairs, entryways and building orientation.

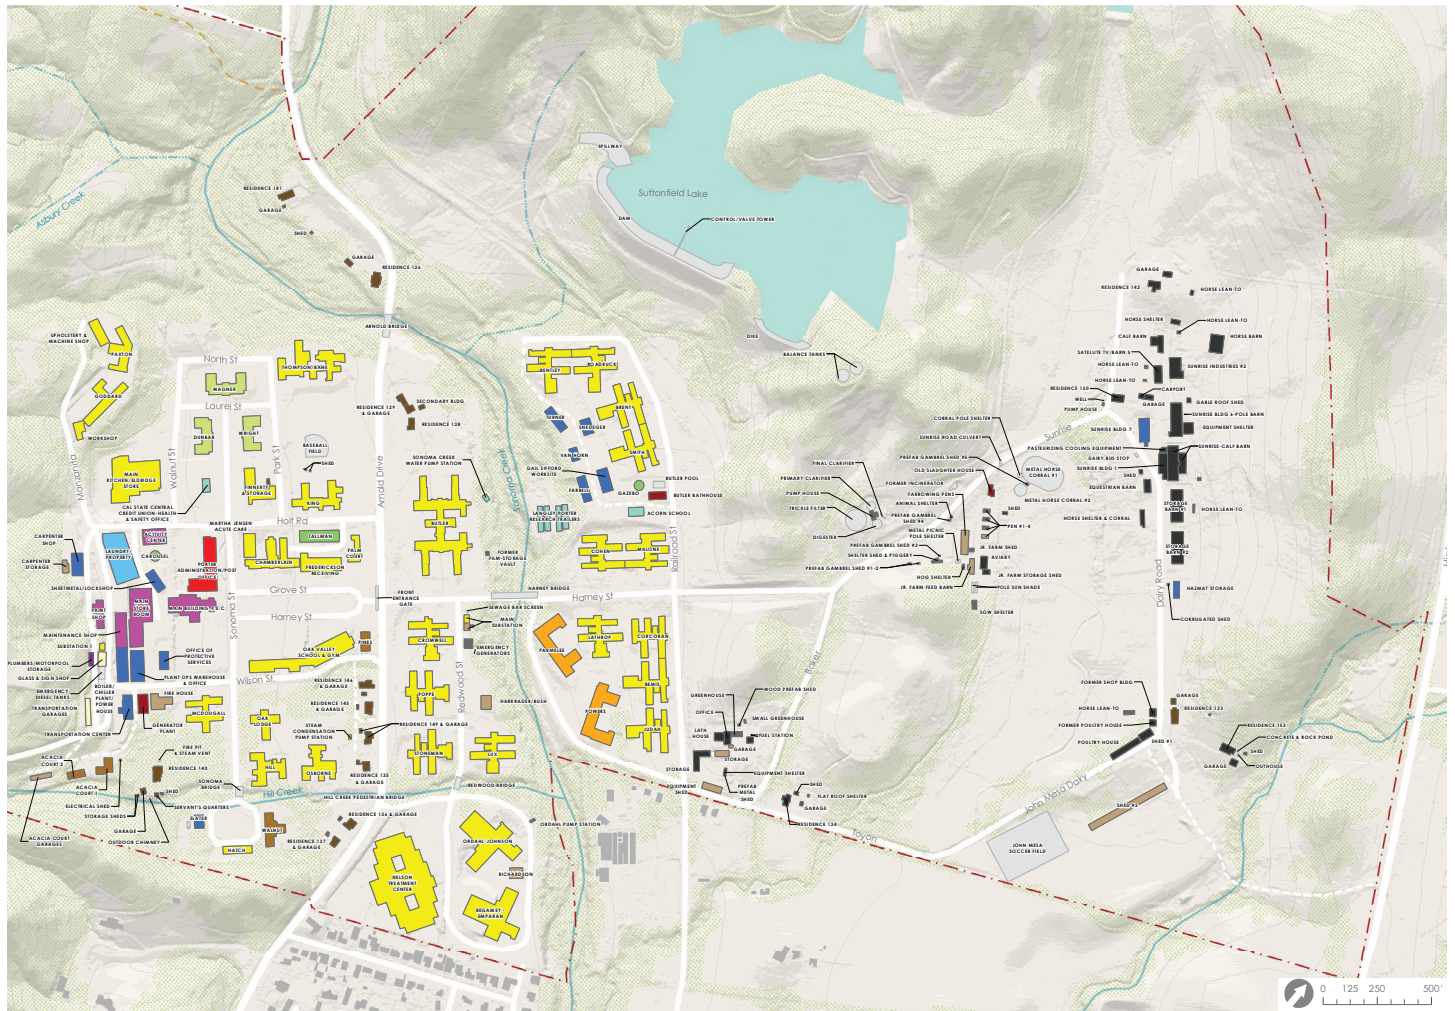
Figure 7-19
PRIMARY BUILDING STRUCTURAL SYSTEM

DCI Engineers classified each surveyed building in the Phase 1, Level 1 Rapid and Level 2 Detailed Assessments by structural type as part of their overall assessment. DCI initially identified 9 structural types present at SDC during the Level 1 Rapid Assessment. The number of structure types was refined to 12 during the detailed assessment through existing document review and additional observation, and these 12 structure types are listed below. Note that some buildings incorporate a combination of different structural types, such as a wood frame second story over a concrete shear wall, see Figure 7-19.

- This is the only building type on the SDC campus for single-family residences. On the SDC campus structures of this type are in good to fair condition, are occupied, and are single-story. Some exceptions are that Residence 140 “Sonoma House” is multi-story, Residence 141 has fire damage in the kitchen area, and Residence 146 is in poor condition due to water infiltration and mold damage.

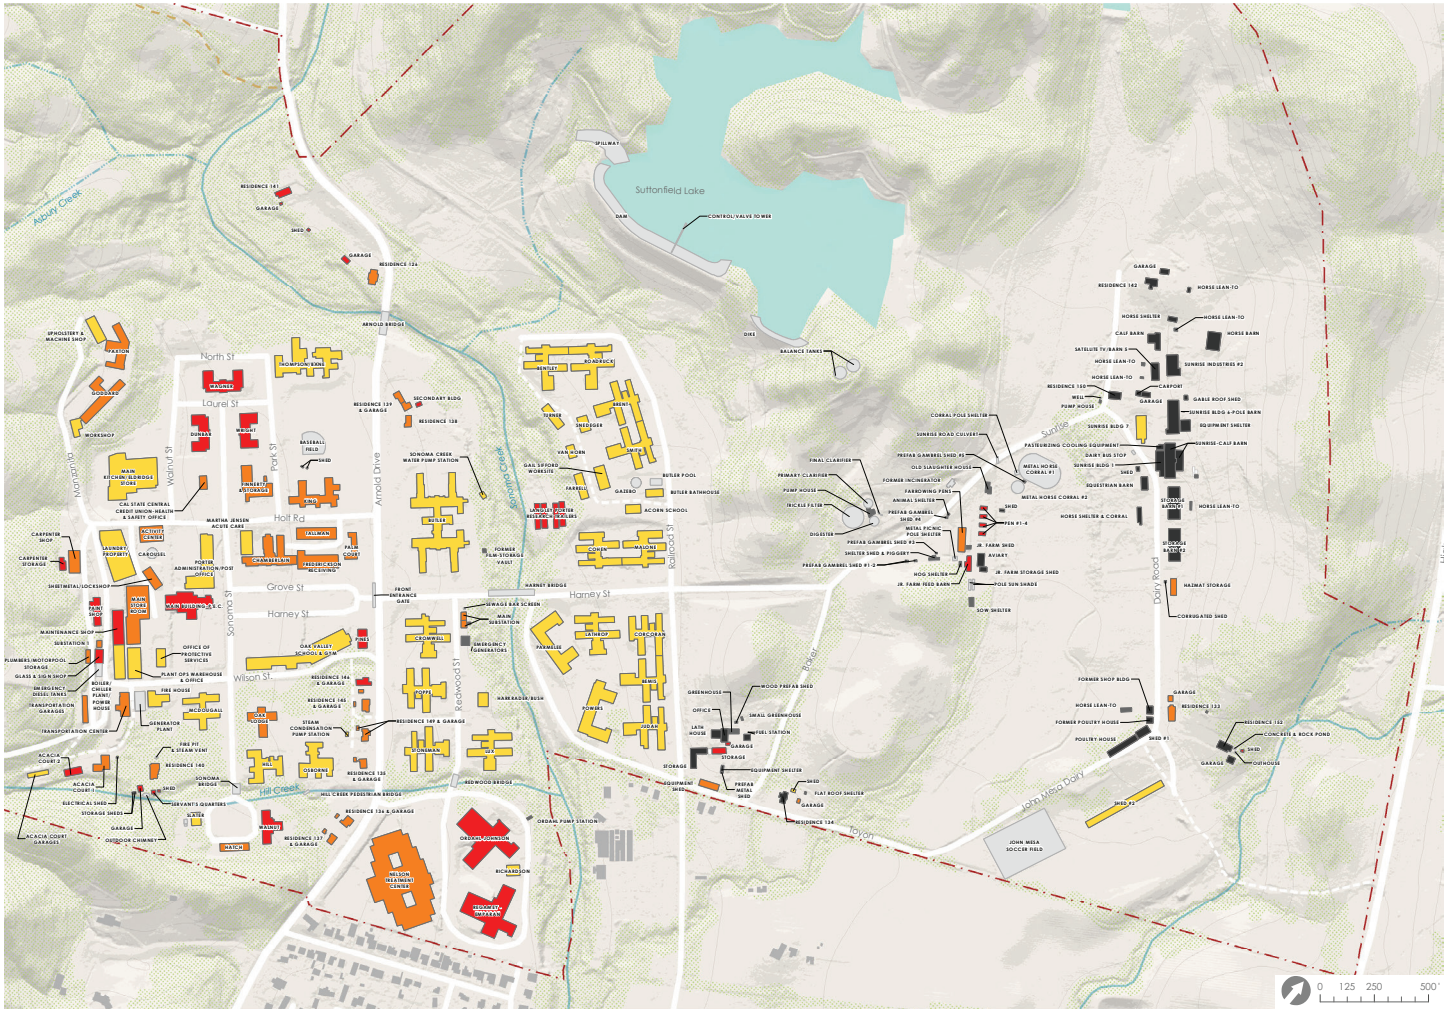
Figure 7-20

Assessment Figure 7-19 and 7-20: this map identifies the recommended level of strengthening required (minimal, standard, or major):

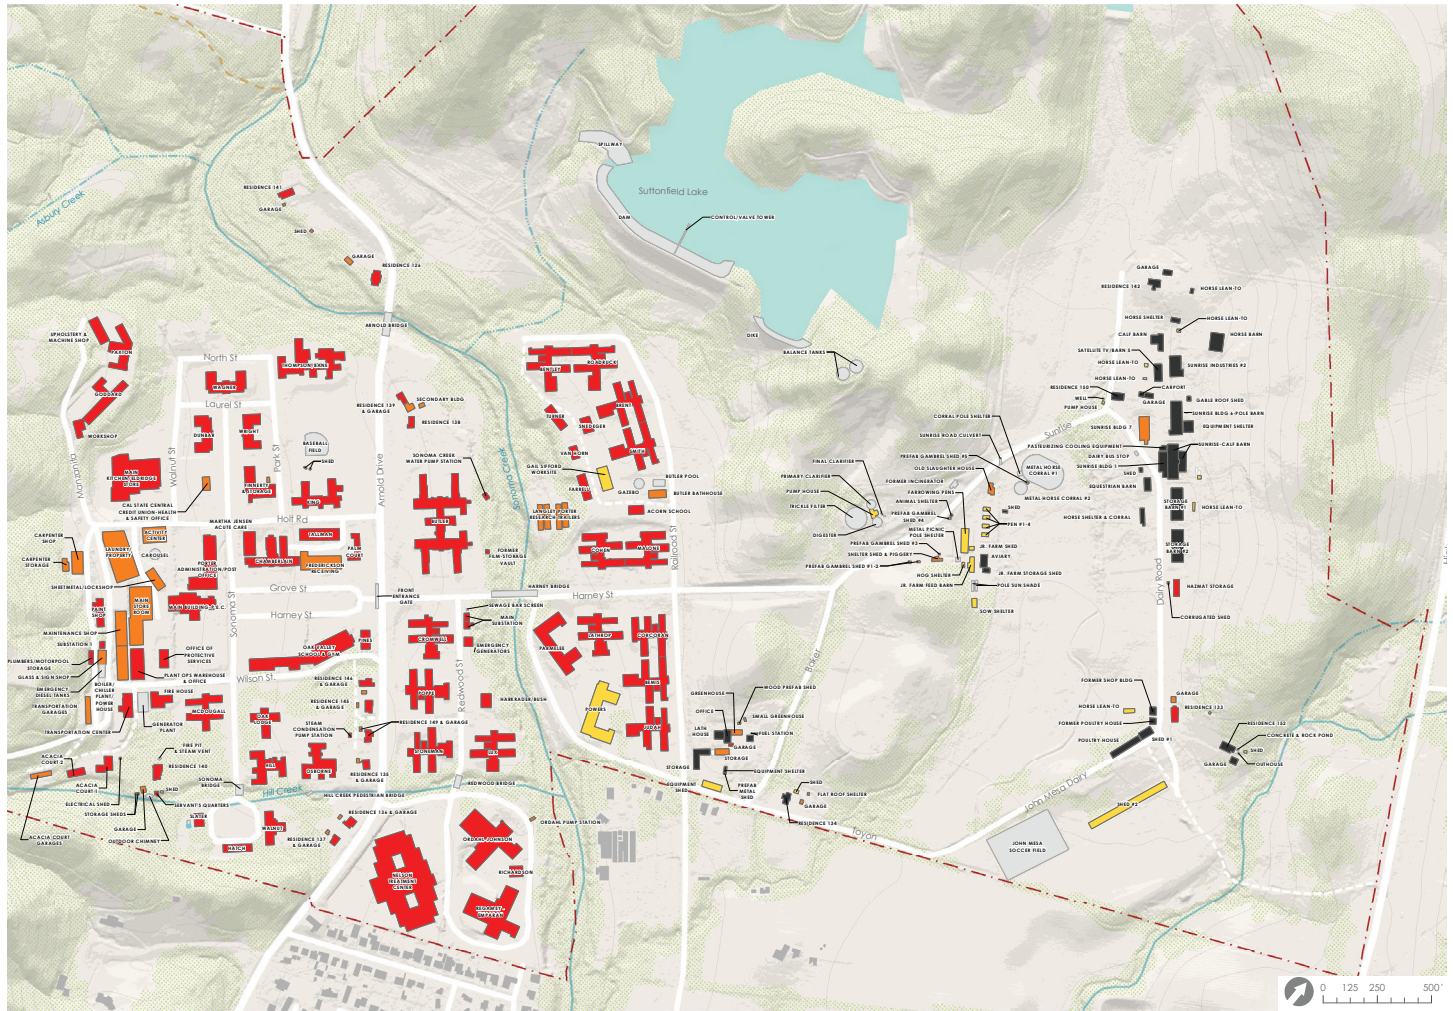
Figure 7-21

Figure 7-21: this map applies historical unit costs for the removal and abatement of various hazardous materials observed or presumed to exist to determine a preliminary budget for remediation. Influencing cost factors include the presence of surfacing asbestos materials, pipe insulation, the presence of asbestos debris in crawl spaces and the relative available access to these crawl spaces. As a result, the simple buildings and structures were assigned a cost of \$0.01-\$4.99/SF as a budget number. The highest per square foot estimated cost for building remediation as SDC is \$18-22, while the highest cost for utilitarian-type structures is \$89/SF for the landscape fuel station.
